**COLLECTION OF REPORTS ON VIBRATION SURVEYS**

**PUGET SOUND NAVAL SHIPYARD**

**TR-23626  
BUSHIPS 9400-2**

Subj: USS IWO JIMA (LPH2); report of underway vibration trials

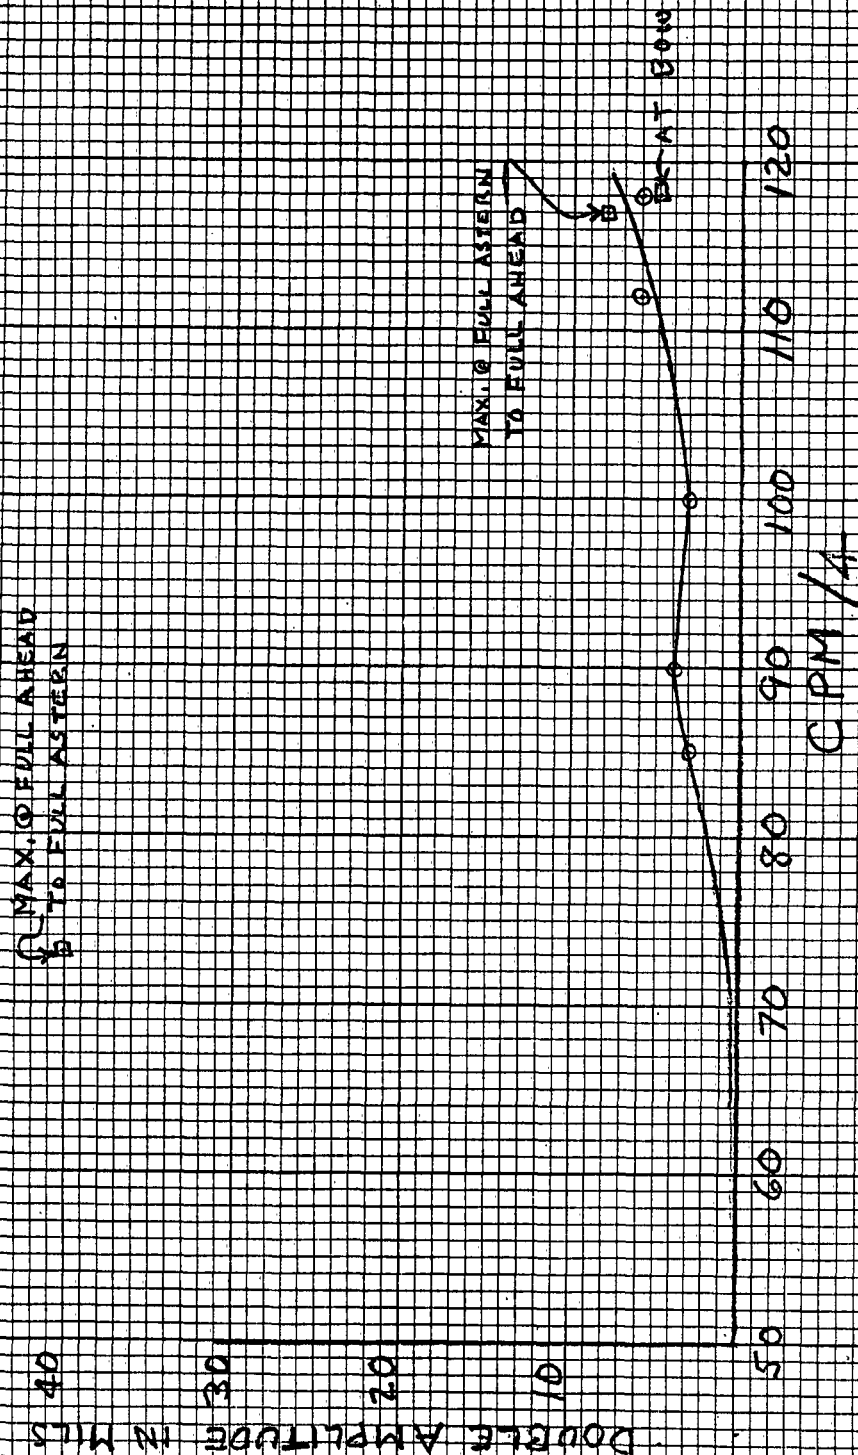
FIGURE II

5. Evaluation of these data indicates that there is no definite hull resonance condition at speeds 50 SRPM and above. A slight peak is evident in both the vertical and transverse directions at about 90 SRPM. This slight rise could be due, however, to anomaly in the experimental conditions or ship response. During the speed increase from astern to full power ahead there were a few cycles of vibration at increased amplitude at about 6.2 CPS, corresponding to a fourth order at 92 SRPM, which also might indicate a resonant condition. Still, such amplitude increases also occurred at other speeds during this build-up but are not reflected in the curve for incremental speeds. In any event, the resonance, if present, is of no serious consequences. Vibration is mild in free route up to 100 SRPM. Above 100 SRPM, amplitudes increase to a maximum of 21 mils in the vertical direction and to a much smaller degree in the transverse direction. It appears that a hull resonance is approaching in the vertical direction at full speed. Decks and bulkheads in areas throughout the ship respond to both the fourth order excitation and, primarily in the after part of the vessel, to the higher frequency components which are present in the wave form. Most difficulty from such vibration is experienced in the medical spaces where it is difficult to write and perform such duties as reading a microscope under full
